## INVENTORY FORM FOR STATE HISTORIC SITES SURVEY

Reward

Middleton House

QA-218

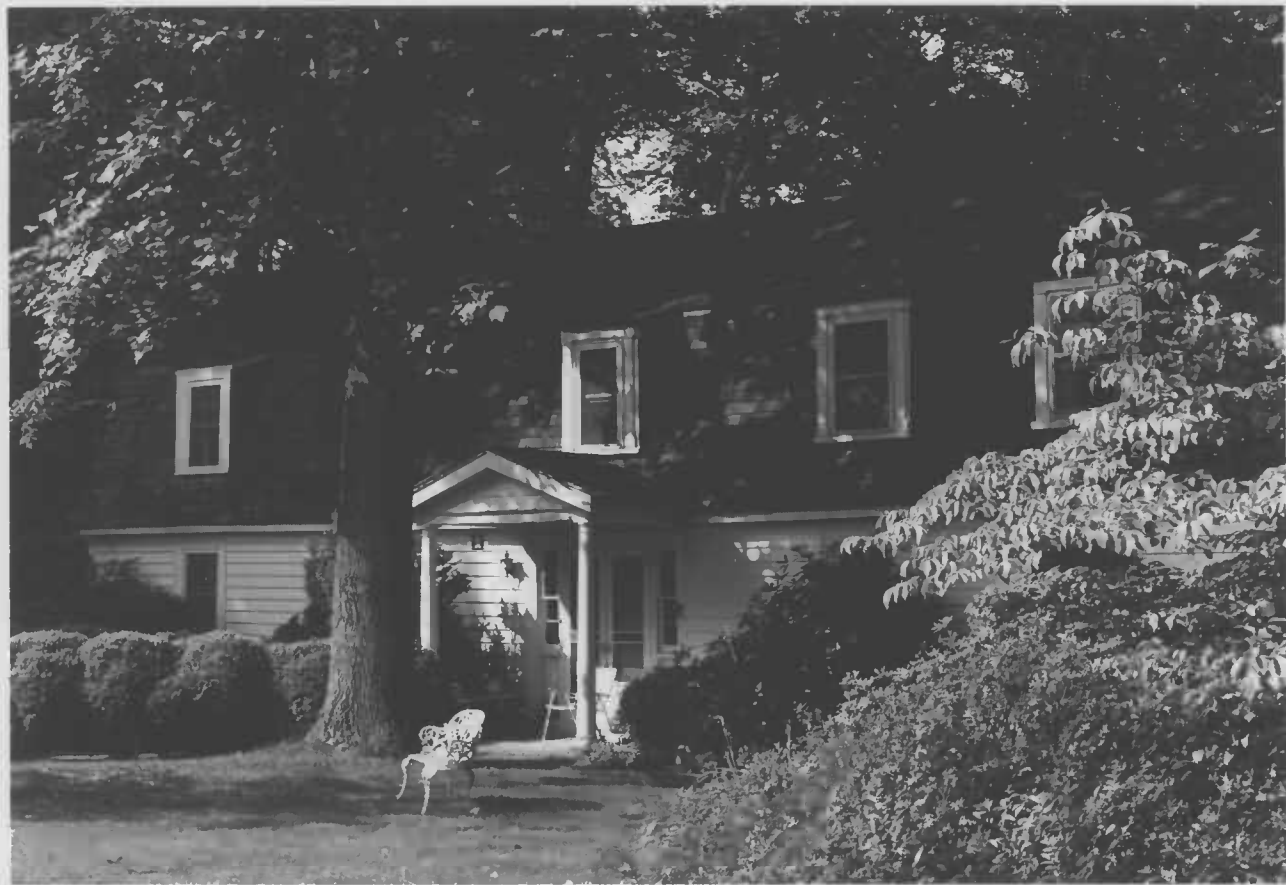
QA-218    Middleton House, "Reward"  
          Centreville vicinity  
          Orlando Ridout V    1980  
          Southwest facade

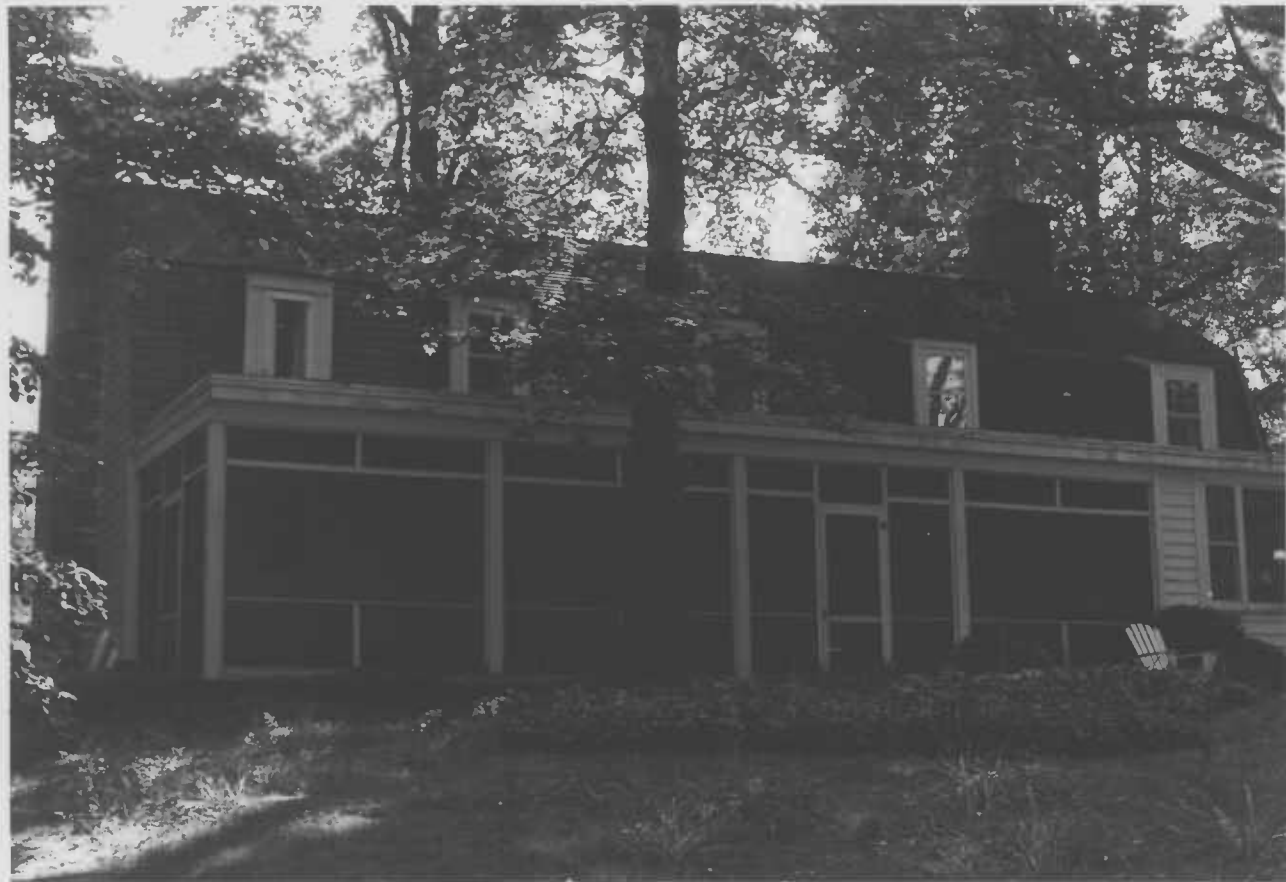
QA-218     Middleton House, "Reward"  
              Centreville vicinity  
              Orlando Ridout V 1980  
              Northeast facade
